INSPECTION REPORT
Sample New Construction 3 Story Townhouse

DUE DILIGENCE™

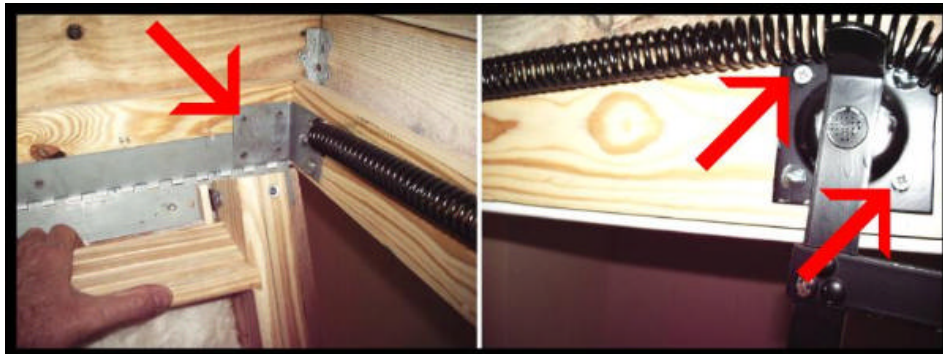
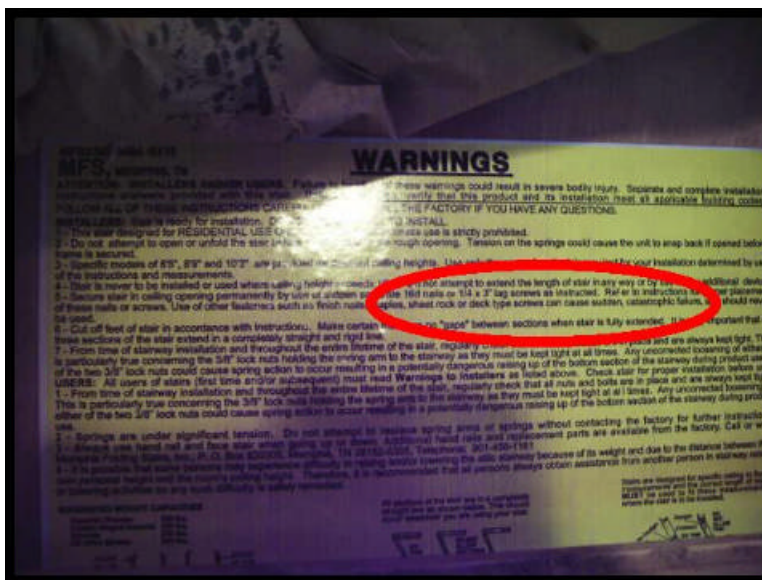
Improper fasteners (drywall or deck type screws) used to fasten attic folding stair frame. Recommend fastening folding stair properly at holes in accordance with manufacturers instructions. See warning label on unit item #5.

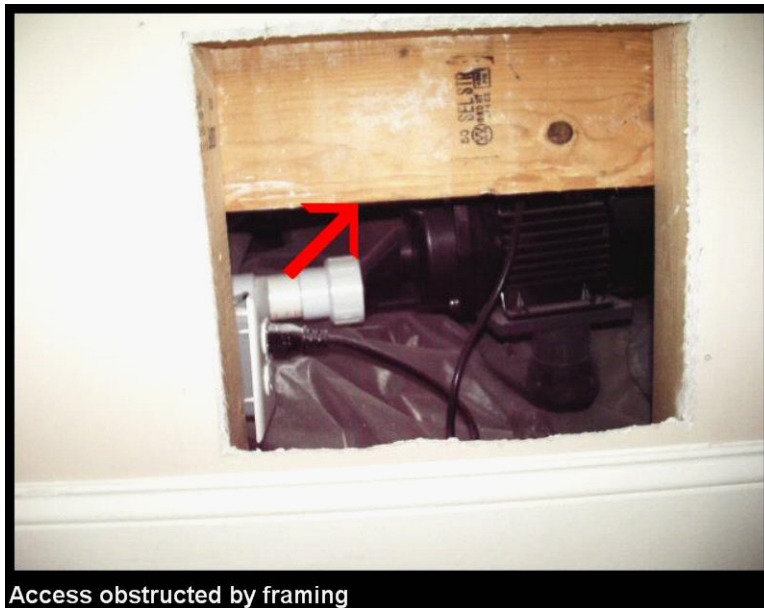
LAVATORY: Appears serviceable.
CABINET: Appears serviceable.
TOILET: Appears serviceable.
TUB / SHOWER FIXTURES: Appears serviceable.
WHIRLPOOL TUB: Access to pump is obstructed by framing member across top of access. Repairs as necessary recommended. Reference 2006 International Plumbing Code Article 421.5.

Access obstructed by framing

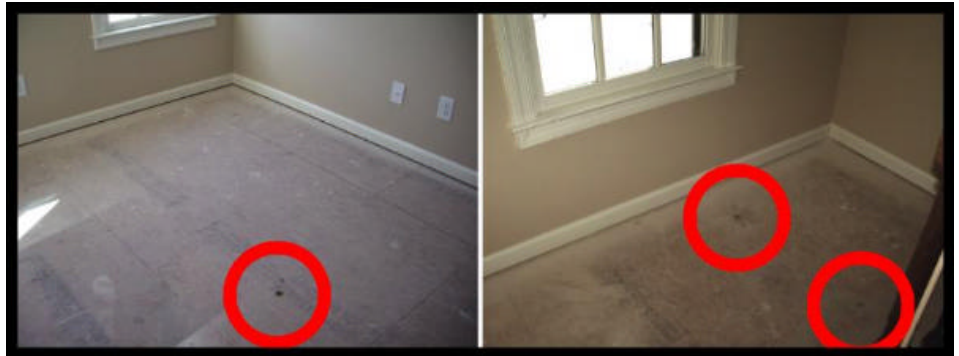
CONDITION: At least three small holes noted in subfloor at third floor. Repairs as necessary recommended.

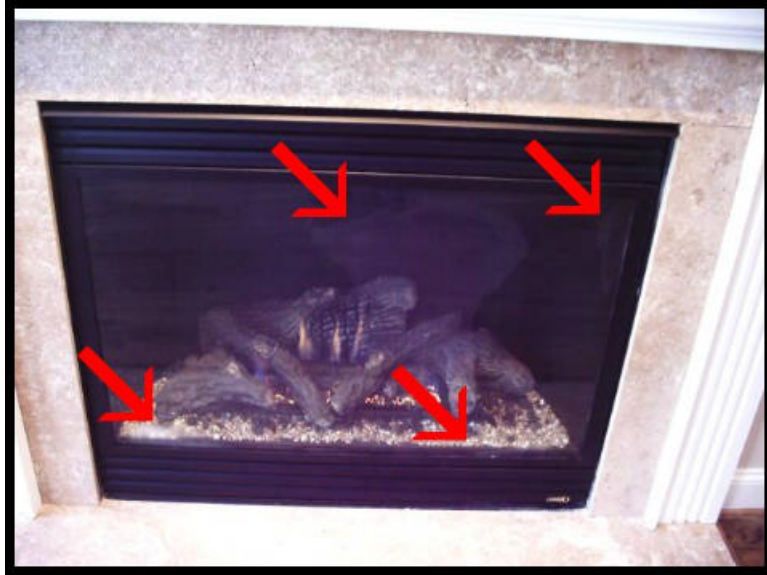
LIVING ROOM: Direct vent gas fired appliance. Some stains on inside of glass, probably deposits left by condensation that dried on glass. Repairs as necessary recommended.

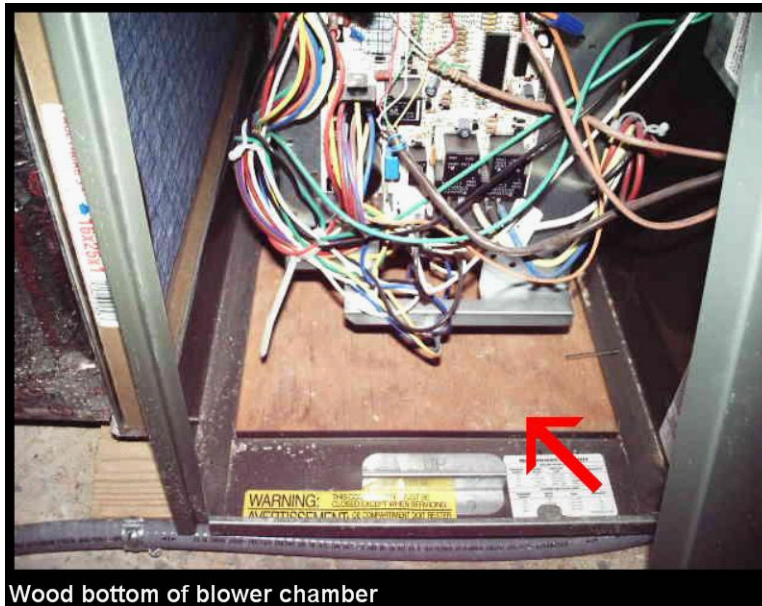
LOCATION OF UNIT: Garage, mechanical room.
SYSTEM TYPE: Forced Air.
ENERGY SOURCE AND NOTES: Natural Gas.
FURNACE AGE IN YEARS: <1.
CAPACITY: 50,000 Btu's.
CONDITION: Appears to be operating properly.
NORMAL CONTROLS: Appear serviceable.
PUMP/BLOWER FAN: The metal bottom is not installed at blower chamber. Furnace is set on a scrap piece of LVL wood beam. Repairs as necessary recommended. Reference 2006 International Residential Code Articles M1307.1 and M1601.3.1.

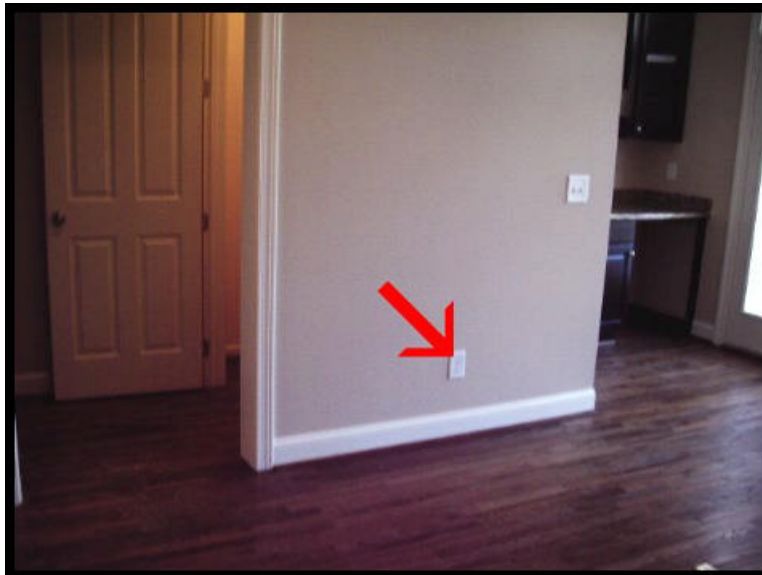
CONDITION: Top socket of receptacle at wall adjoining storage closet in living room appears to be clogged with glue. Replacement recommended. Reference 2008 National Electrical Code Article 110.12(B).

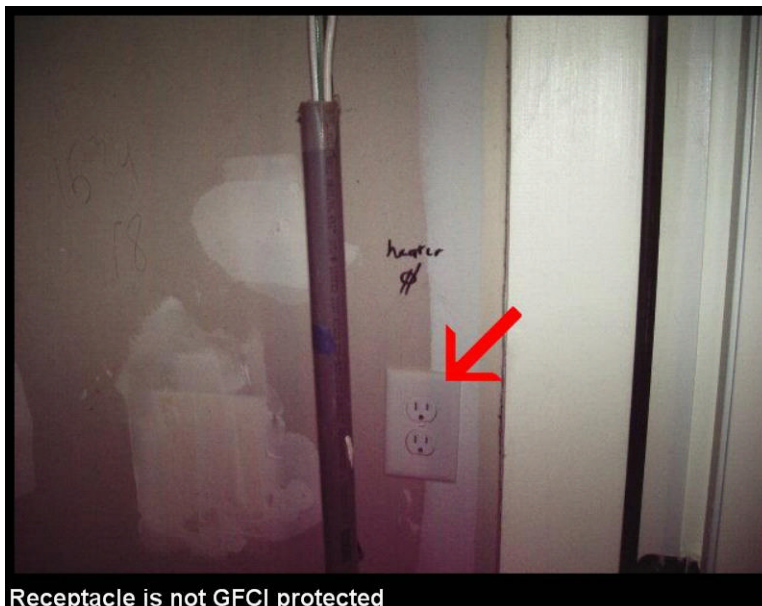
ACCESSORY BUILDINGS, STORAGE AREAS AND WORK AREAS: GARAGE MECHANICAL ROOM: There appears to be no GFCI protected receptacle(s) at this location. Repairs as necessary recommended. Reference the 2008 National Electrical Code Article 210.8(A)(2).

Receptacle is not GFCI protected
