## 2011-01-17 Mold?

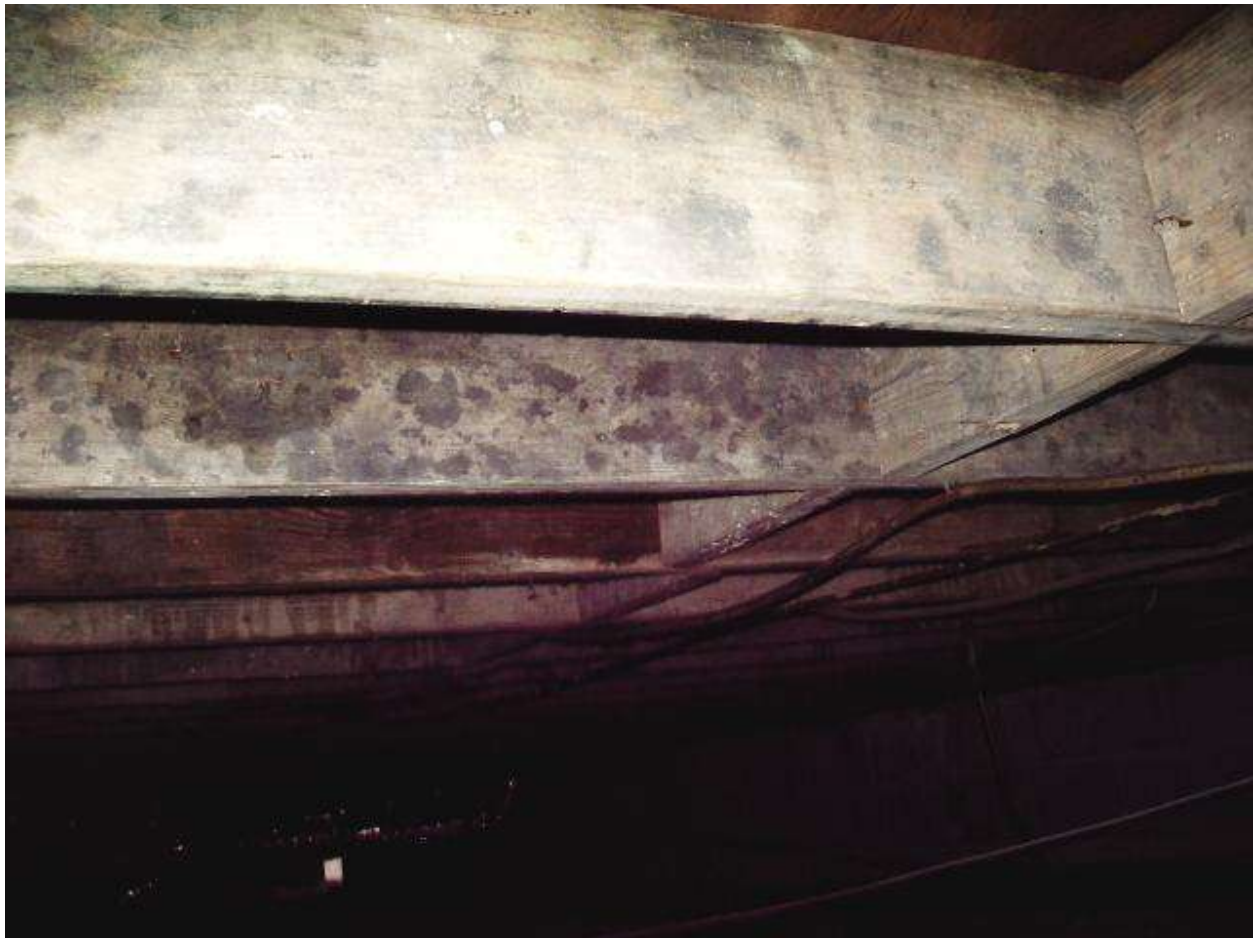
Think it was Hamlet who once observed 'things are not what they seem...' or something to that effect or heck maybe that was just the theme of the entire play. At any rate, this humble home inspector ran into such a situation today. Upon visual inspection (that is what a home inspection is supposed to be) the floor joists... of this 40-something ranch in Norcross looked like they were covered with mold ("Yikes! Holy Cow! Batman!"). Upon tactile inspection, found the joists were covered with spots of cement/mortar residue. Apparently, the builder used scaffold boards from another job to construct the floor system.

Floor joists on this inspection appeared to be covered with mold, turned out to be cement/mortar residue.
